Manhole Inspection Summary

Manhole # **S13CC_030MH**

Insp Date: **6/23/09 3:21 PM**

Location Address: **2901 RIGGS AVE**

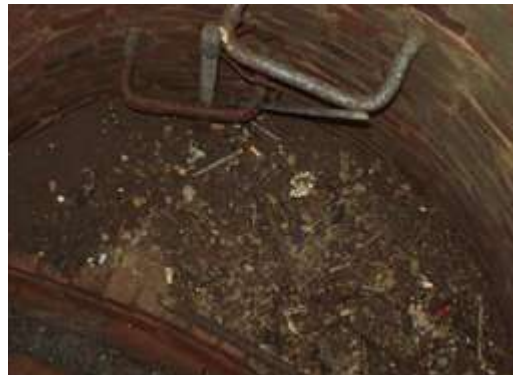
Defect 3

DEBRIS ON BENCH

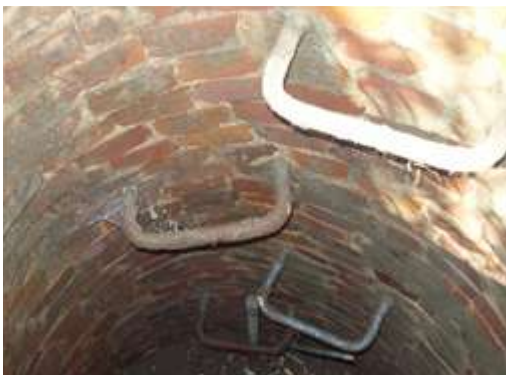
Defect 2

Steps Count: **4** Missing: **0** ☒ **Corroded**

CORRODED STEPS

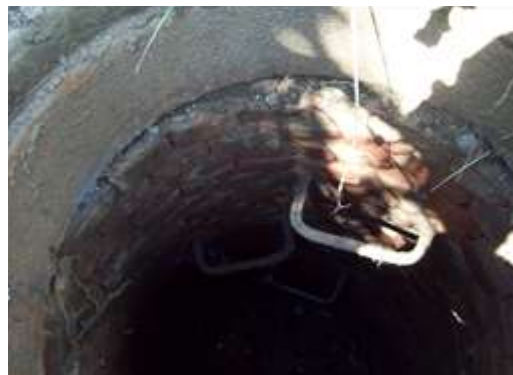
Defect 1

Frame Offset: **1** (in.) Condition: ☒ Sound ☐ Cracked ☐ Leaks

FRAME OFFSET

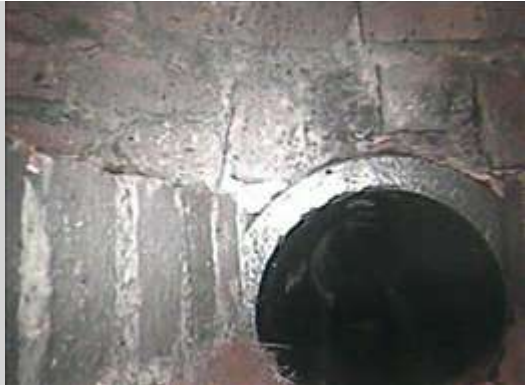
12 O'Clock Outflow

8 in. Circular Gravity Sewer
Pipe Out @ 12 O'Clock

Pipe Height: (in.) Direct
Pipe Material: **Clay** ☐ Pipe Lined
Invert Depth: **8.25** (ft.) Flow Characteristics: **Slow**
Deposits: ☒ None ☐ Mud ☐ Sludge ☐ Debris ☐ Grease
Silt Depth: (in.) Deposits Extent:
Infiltration: **None** Pipe Seal Cond: **Sound**

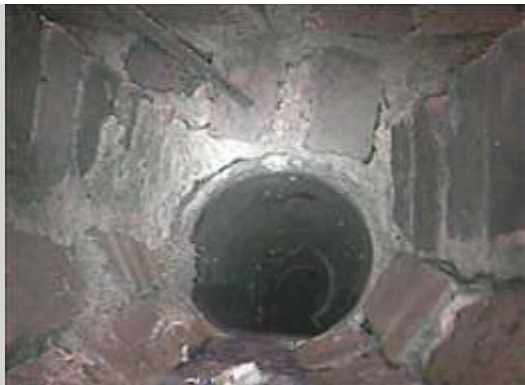
7 O'Clock Inflow

8 in. Circular Gravity Sewer
Pipe In @ 7 O'Clock

Pipe Height: (in.) Direct
Pipe Material: **Clay** ☐ Pipe Lined
Invert Depth: **8.15** (ft.) Flow Characteristics: **Slow**
Deposits: ☒ None ☐ Mud ☐ Sludge ☐ Debris ☐ Grease
Silt Depth: (in.) Deposits Extent:
Infiltration: **None** Pipe Seal Cond: **Sound**
